Subject: Addendum to Remedial Action Plan – AOC 1, AOC 5, AOC 9 and AOC 14
Closure Plan Part 1 CSA
Montville Generating Station
Montville, Connecticut

Attachment 1

CSA Photos

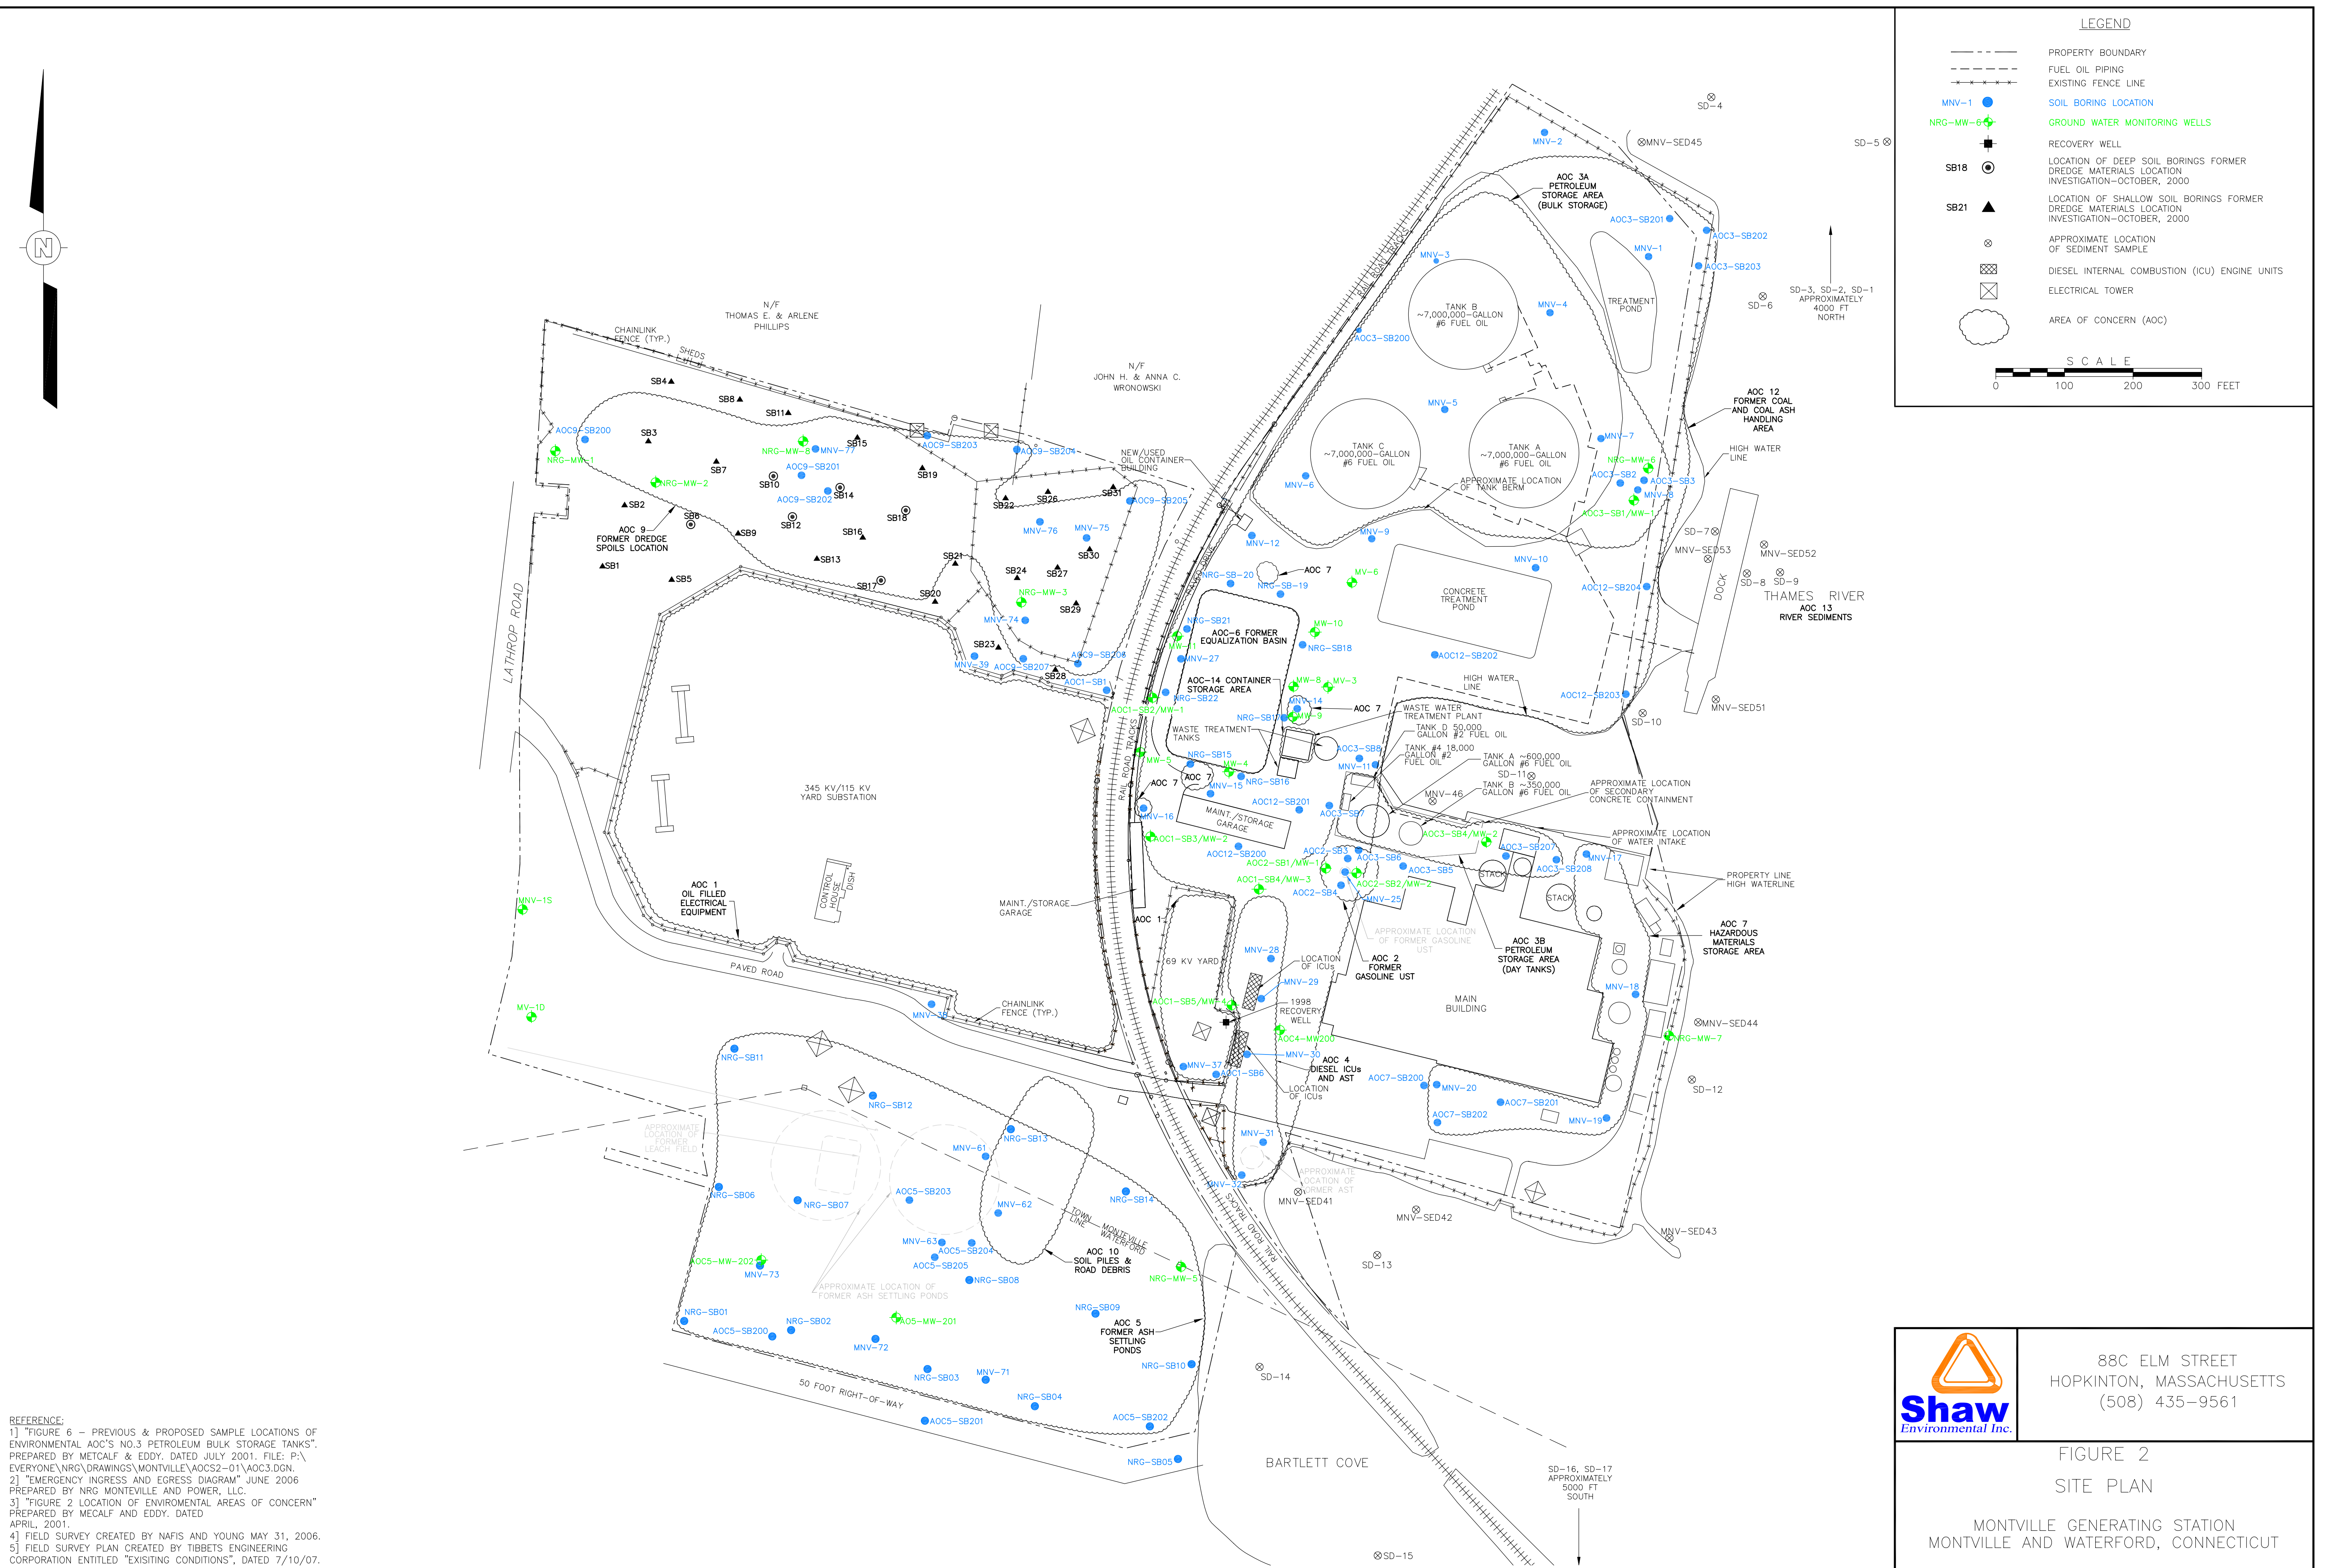
Site Plan – Figure 1
CSA Plan – Figure 2

On March 25, 2009, a detailed inspection of the CSA was completed by Shaw in accordance with the June 17, 2009 RAP. This included an inspection of the concrete floor, the 8-inch high and 6-inch wide concrete berm along the north side of the CSA, and the concrete walls on the south, west and east sides of the CSA. The concrete floor appeared to be in good condition with the exception of a small section of chipped concrete floor in the southeast area of the CSA by the stair case and some mineral staining noted on the floor in the southwest and west areas of the CSA. The staining is likely due to groundwater infiltration along the piping that enters the CSA at the southwest corner of the building and runs along the west side of the CSA. This piping is approximately 2-feet above the concrete floor and is associated with the waste water treatment plant. One small surficial crack was noted in the southwest vertical column of the CSA starting at the base of the column. In addition, one capped pipe was observed at the east side of the CSA. This pipe vertically penetrates the CSA floor, is cut approximately 5-inches above the floor and appears to be rusted. According to NRG, the destination and use of this pipe is unknown. A sketch of the CSA is included as **Figure 2**. Photos of the CSA are provided as **Attachment 1**.

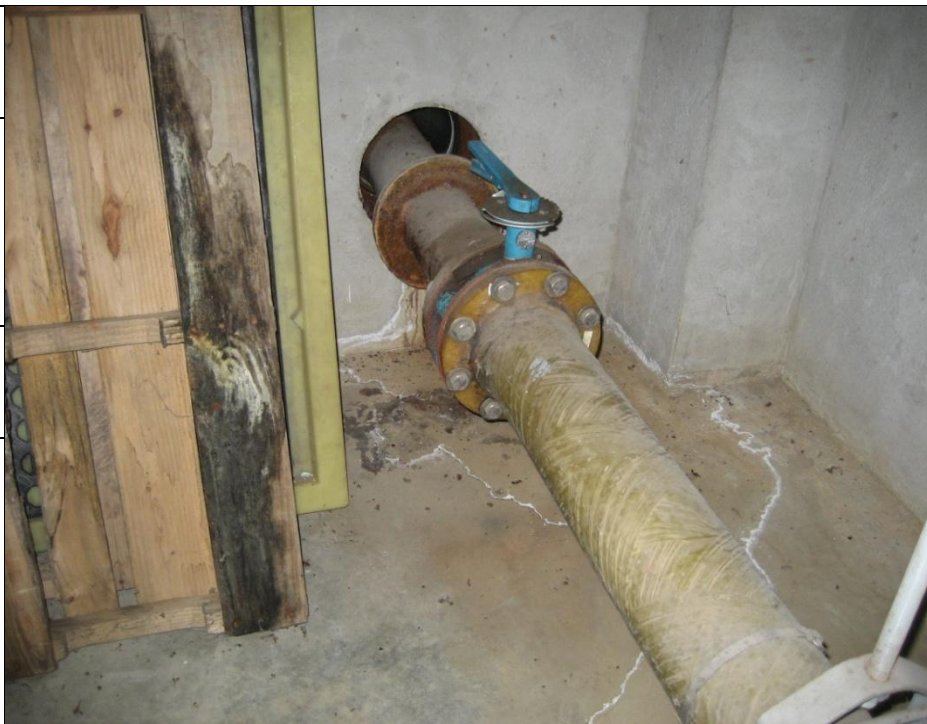
- There were no obvious stains on the CSA floor with the exception of mineral staining from water in the southwest and west areas of the CSA.
- The integrity of the concrete floor appears to be in good condition with the exception of a small section of chipped concrete floor in the southeast area of the CSA.
- The integrity of the concrete walls and berm appears to be in relatively good condition with the exception of a small surficial crack in the vertical column located in the southwest corner of the CSA.
- A capped pipe was observed in the east side of the CSA. This pipe vertically penetrates the CSA floor and the pipe destination and use is unknown.

Piping through southwest wall of CSA and mineral stain on floor

Shaw proposes to clean the CSA floor and collect concrete chip samples as described below:

1. The floor and secondary containment inside of the CSA will be steam cleaned and wash water will be collected by a wet/dry vacuum cleaner during cleaning activities. The wash water will be drummed and characterized for proper disposal. The wash water will be analyzed for the following: VOCs, SVOCs, ETPH, 13 priority pollutant metals, PCBs, reactivity, corrosivity, and ignitability.

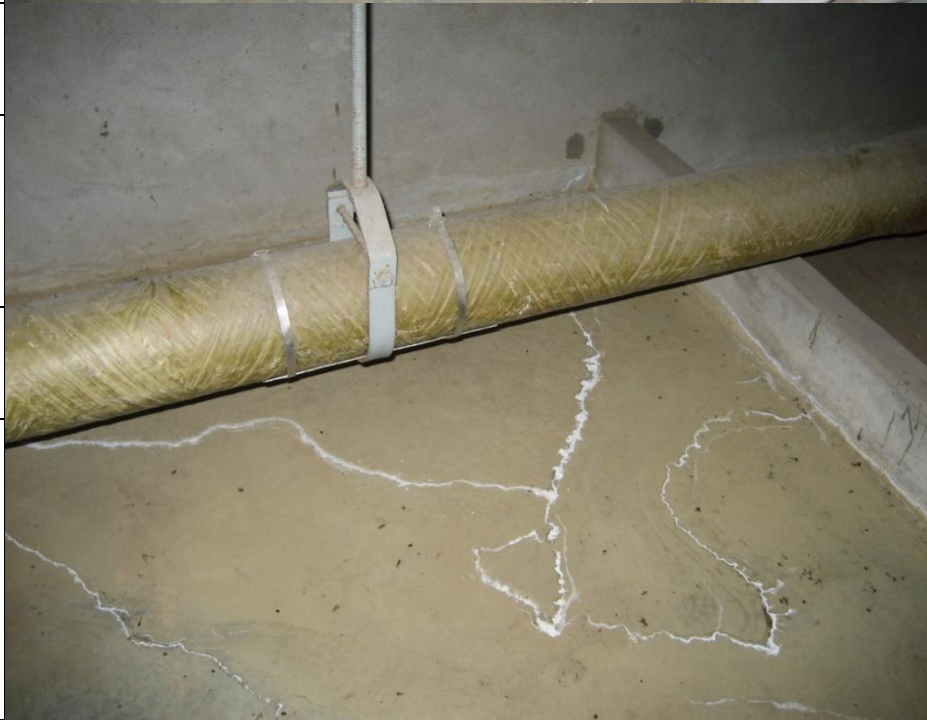
Piping along west wall of CSA and mineral stain on floor

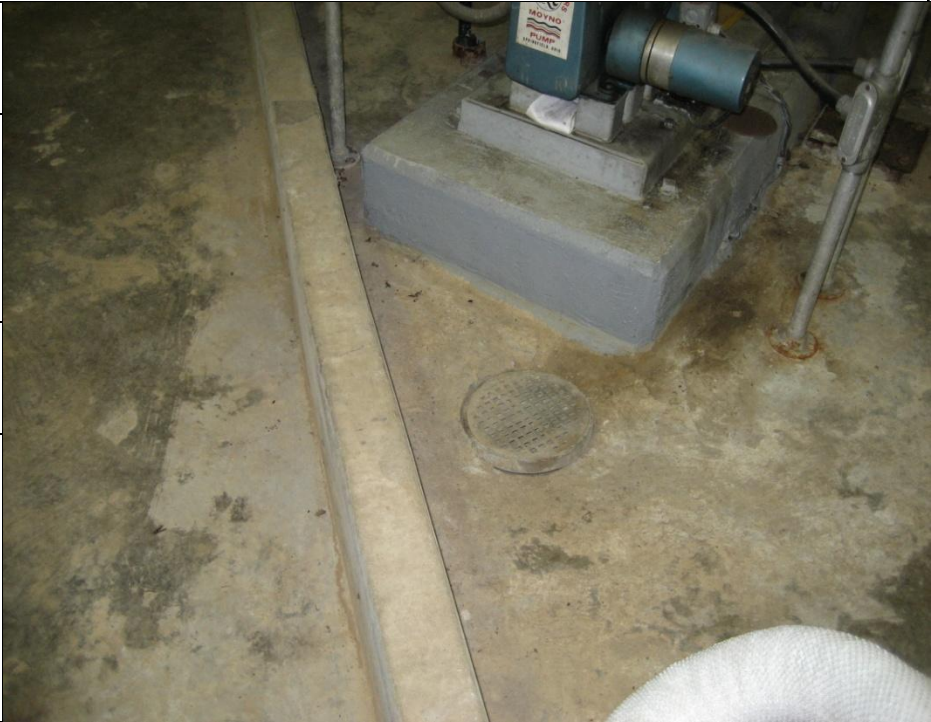
Date: March 25, 2009	
Direction: North of CSA	
Comments: Berm north side of CSA (CSA is to the left)	
Photographer: Joe Pickard

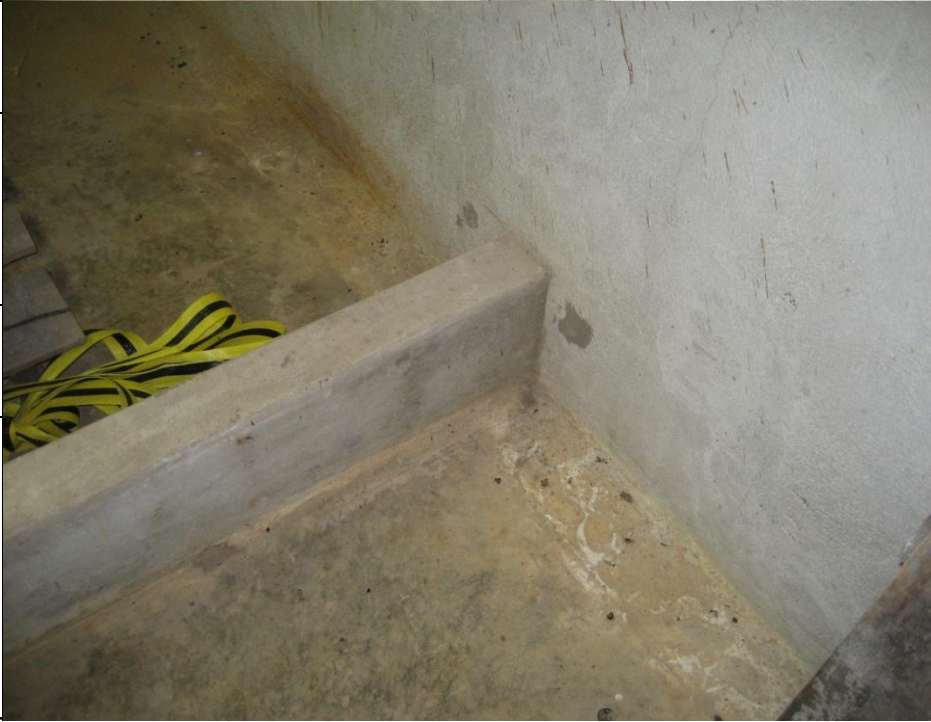
Date: March 25, 2009	
Direction: Northwest	
Comments: Berm Wall Joint (CSA is to the top of photograph)

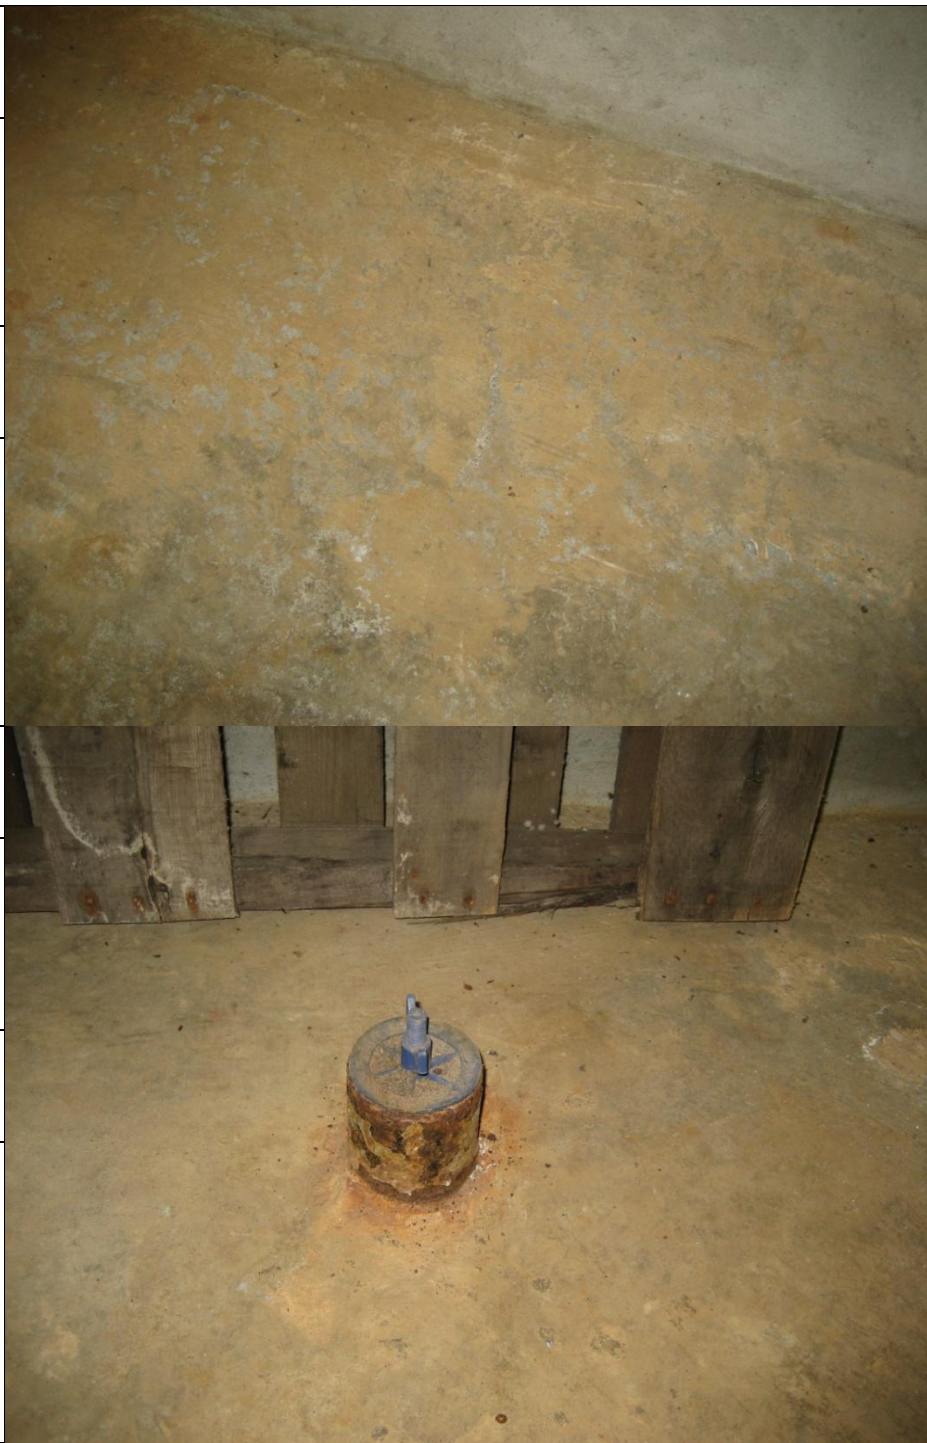
Chipped Concrete
Floor Southeast Area
of CSA

Capped Pipe on East
Side of CSA
